Review of Northumbrian Water's response to Storm Arwen

Northumbrian Water

Storm Arwen Assessment
13 April 2022

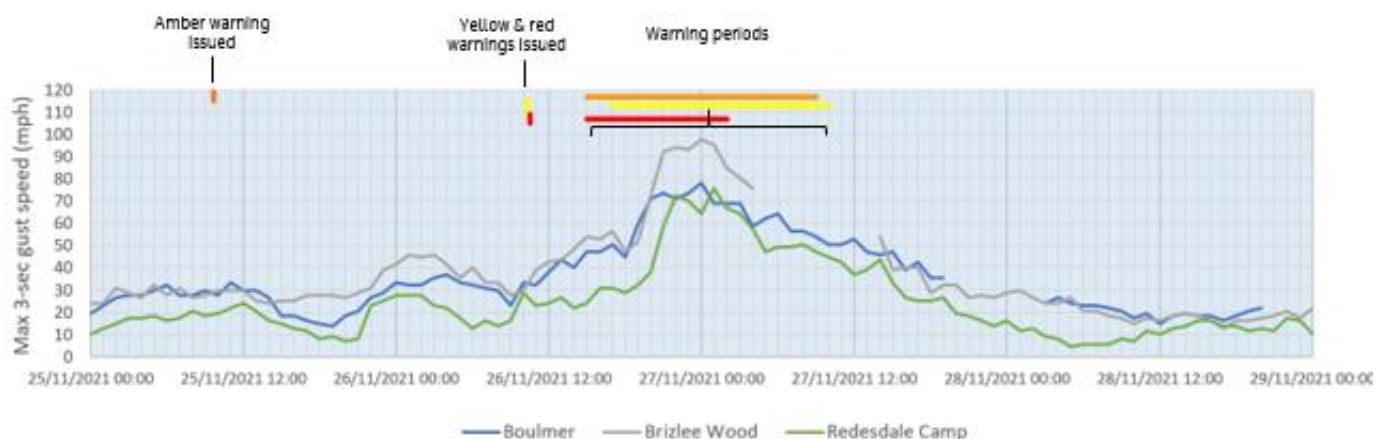
Figure 2-1: The occurrence of Storm Arwen together with the Met Office warnings

Figure note: Met Office warnings: yellow for snow, amber and red for wind. In all cases, the first marker indicates when the warning was issued. The solid line indicates the period over which the warning applied

Storm Arwen brought severe winds across the UK over the night of 26 - 27 November 2021, with the Met Office issuing a red warning for wind down the north-eastern coast of Britain. The storm, tracking south to the north-east of the UK, brought northerly winds gusting widely at over 69mph (60Kt). This was one of the most powerful and damaging UK winter storms of the latest few decades, with the highest (non-mountain) gust speed of 98 mph being recorded at Brizlee Wood in Northumberland. The main hazard was wind, though Arwen also brought some very low temperatures for the time of year and some significant snow accumulations, particularly to parts of the Pennines. The Met Office provided yellow, amber, and red warnings for wind and snow, as shown in Figure 2-1, Table 2-1, and Figure 2-2.

The extreme wind speeds at the Boulmer and Brizlee Wood Met Office stations peaked over a 6-hour period (20:00 Friday 26 November – 02:00 Saturday 27 November) about 35 hours after the Amber warning was issued, and 9.5 hours after the Red warning was issued. The winds peaked 2 hours later at the Met Office Redesdale Camp station to the west.

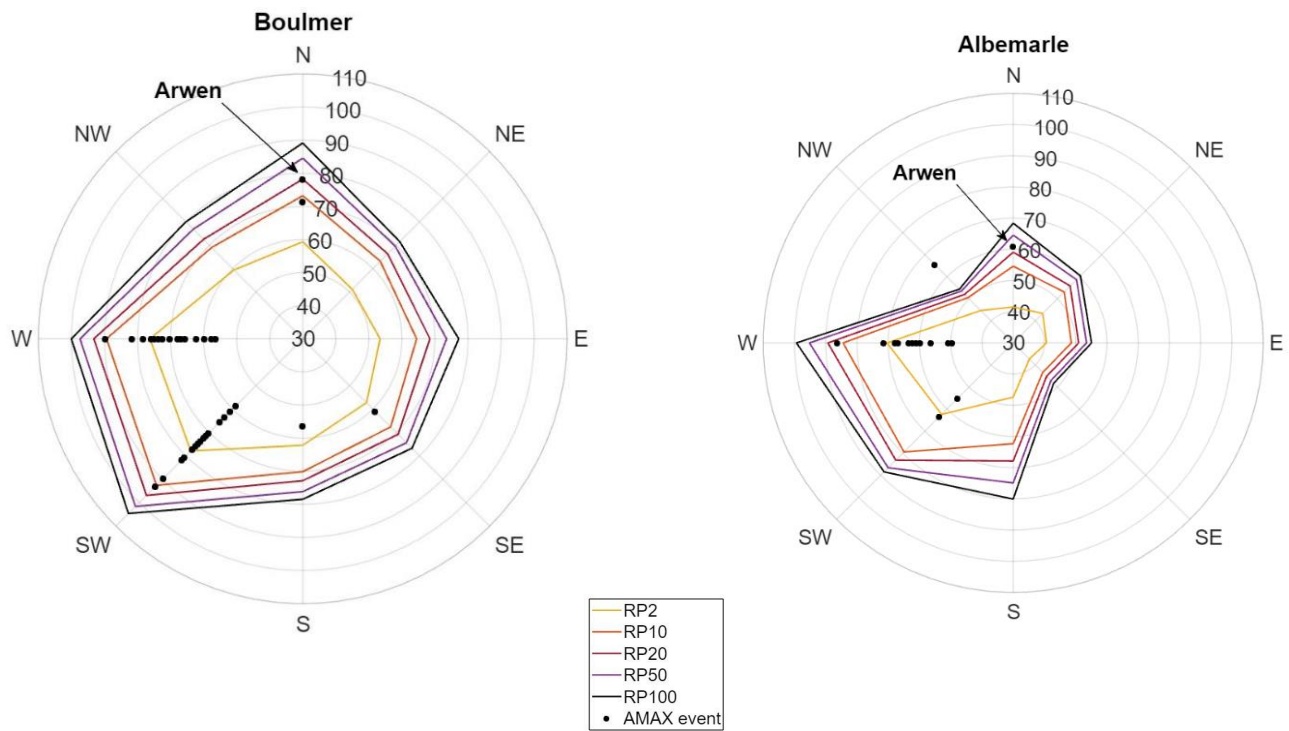
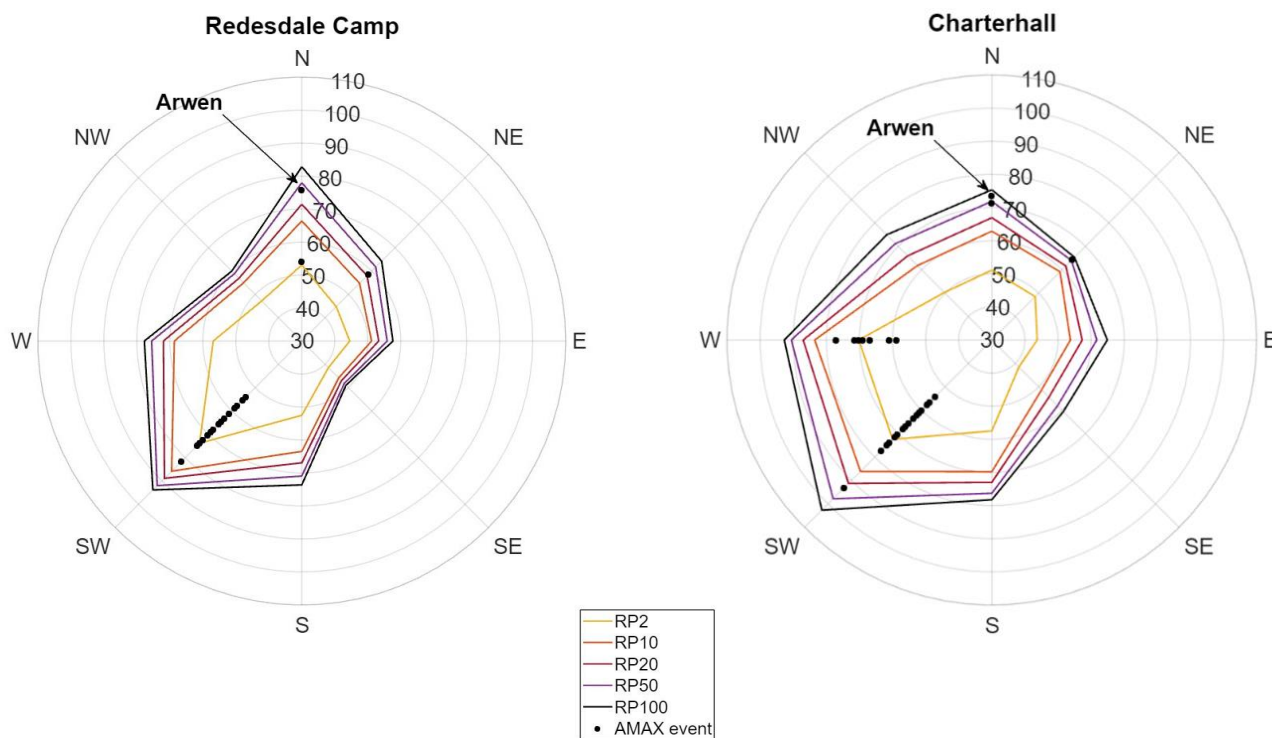
Figure 2-4: Maximum 3-second gust (mph) of Storm Arwen and the other AMAX events plotted by wind direction and compared to directional rarity analysis (RP = return period in years)

Figure 2-4 (cont.): Maximum 3-second gust (mph) of Storm Arwen and the other AMAX events plotted by wind direction and compared to directional rarity analysis (RP = return period in years)

To investigate the directional rarity of the storm, statistical analysis of the wind data was undertaken in each of eight directions (N, NE, E, SE, S, SW, W, NW). The annual maximum series for each of the eight directions were created based on 45-degree segments. For example, records with a maximum gust recorded at a compass bearing of between 337.5 to 22.5 degrees were categorised into north, records from 22.5 to 67.5 degrees into northeast, and so on.

As for the non-directional analysis, the GEV distribution was fitted to each of the directional AMAX series. The results are plotted on rose-diagrams in Figure 2-4. Added to the diagrams are the plotting positions of the AMAX storms obtained in the non-directional analysis. As expected, the plots show that most extreme winds are a result of westerlies or south-westerlies (the prevailing wind direction). However, Arwen’s extreme winds stand out as being different (from the north). Figure 2-4 shows that the speed and direction of Arwen’s winds had a return period of between 1 in 20 and more than 1 in 50 years.

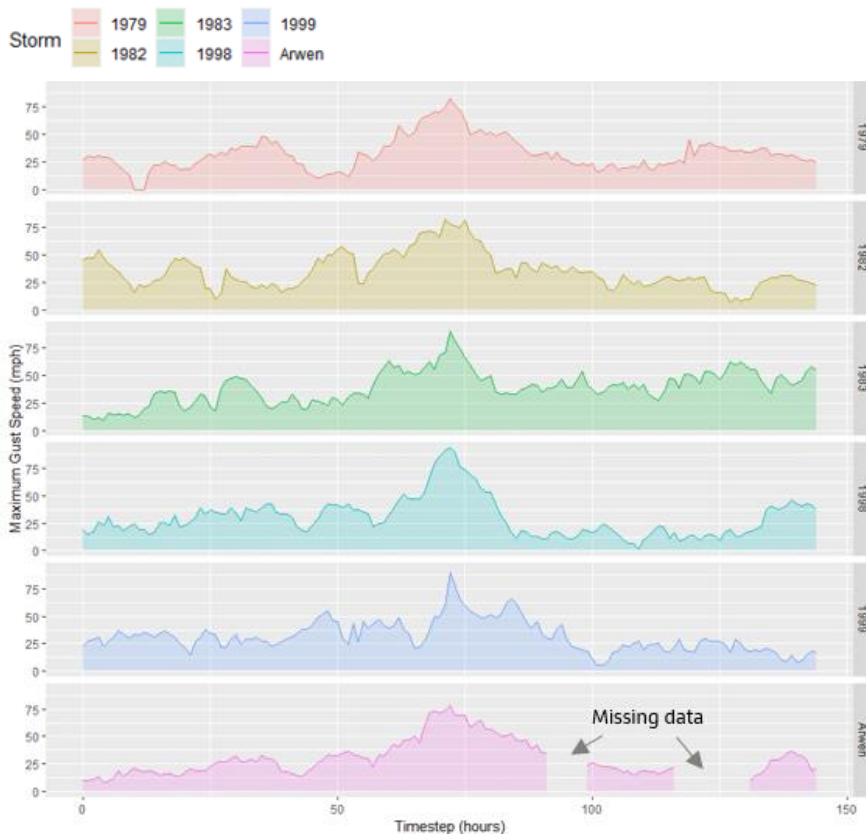
Figure 2-5: Storm Arwen timeseries compared to the top 5 AMAX events at Boulmer¹²

Figure 2-5 compares the temporal profile of Storm Arwen to the top five AMAX storms as recorded at Boulmer. Although the direction of the wind was different to the other events, the temporal profile for Arwen was not unlike other AMAX events, though the windspeeds were slightly slower to drop after the peak.

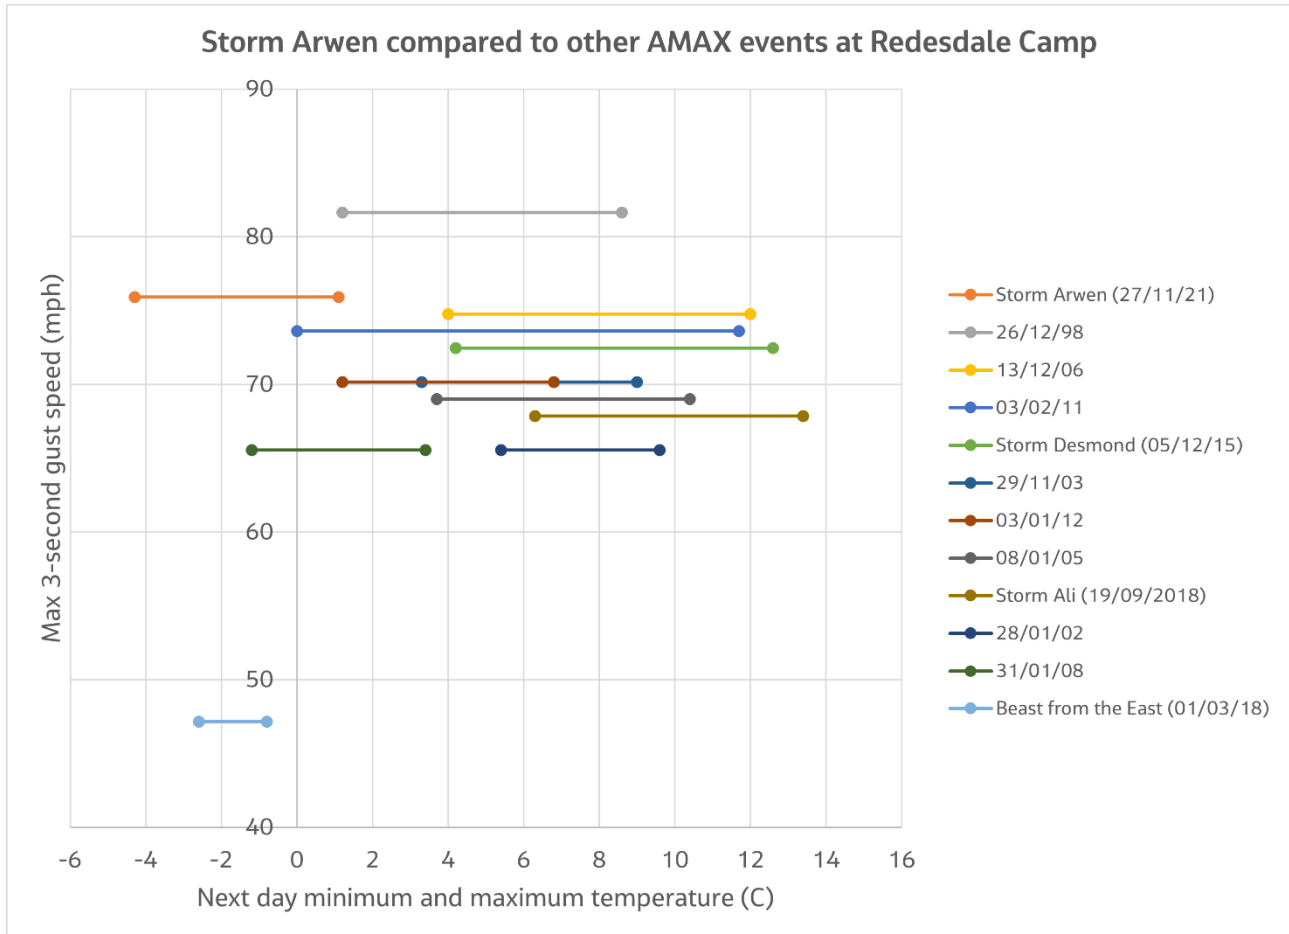
Figure 2-6: Minimum and maximum temperatures recorded at Redesdale Camp the day after the storm event peak plotted against maximum 3-second gust of the storm

The wintry conditions after Storm Arwen caused additional difficulty, with freezing temperatures and snow on higher ground. Compared to the historical temperature records for other AMAX events at the available gauges, this is unusual for extreme wind events. Figure 2-6 plots the minimum and maximum air temperature range on the day after the storm against the maximum recorded gust during the storm for Arwen and the 10 other top ranked storms recorded at Redesdale Camp. For comparison, the same information is plotted for the Beast from the East event (1 March 2018).

The most notorious episode of wintry conditions to have occurred in the last couple of decades was the Beast from the East (over the period 27 February – 10 March 2018). This severe weather event caused a longer duration of freezing temperatures and more significant amounts of snow than Arwen, but as can be seen from Figure 2-6, it did not bring the extreme winds that Arwen did.

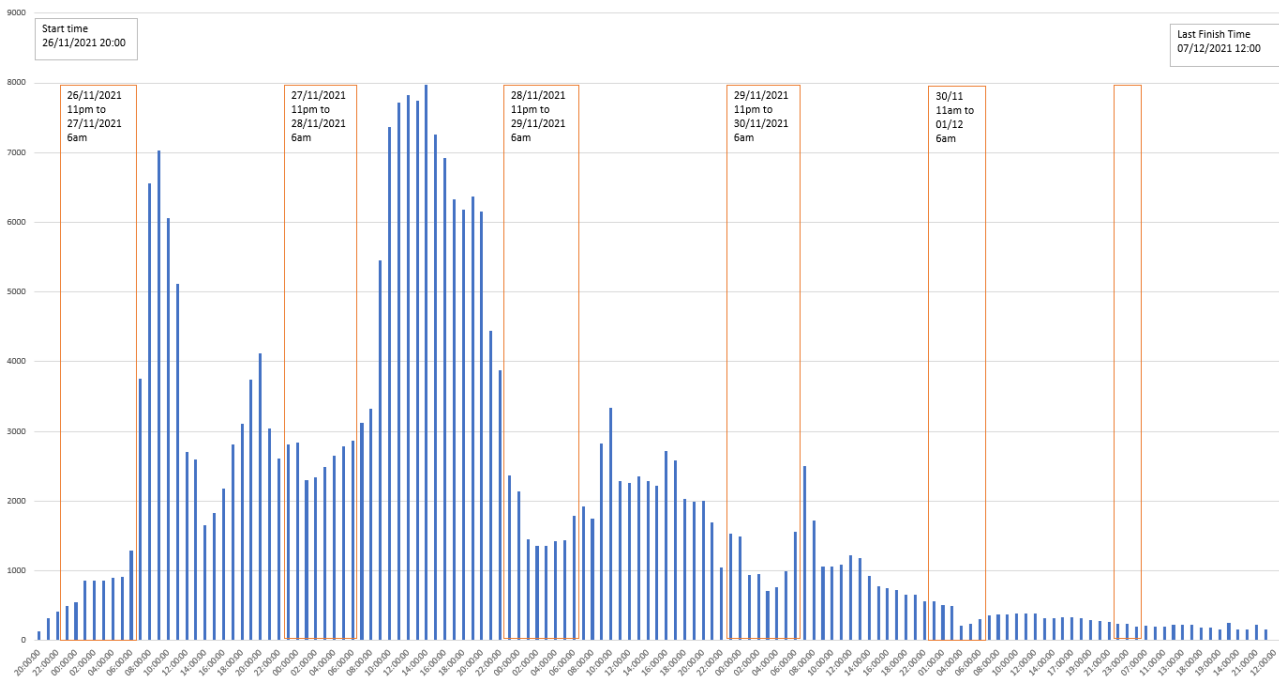
Figure 6-3: NWL analysis of properties impacted by supply interruptions

Data analysed by NWL after the Storm Arwen event indicates that water supply interruptions peaked at approximately 8,000 properties at around 1400 hrs on 28 November 2021 (see Figure 6-3). More than half of these interruptions were restored by 2200 hrs on 28 November 2021. By 0900 hrs on 30 November 2021, interruptions were being experienced by fewer than 1,200 properties. All interruptions were restored by 1200 hrs on 7 December 2021.

Chart shows total number of properties interrupted in any given hour due to Storm Arwen
